# NBS TECHNICAL NOTE 837

## Barrier Penetration Tests

Sixteen structural barrier panels were tested to determine their resistance to forcible penetration through the use of readily available tooling. Thirteen of these represented experimental techniques to reinforce an existing structural barrier of low penetration resistance; the other three were designs which would be most appropriate to consider as replacement barriers. Minimum man-passable sized openings were made in the barriers in working times which averaged 7.85 minutes and ranged from 1.52 to 25.56 minutes. One of the replacement and two of the reinforcing designs showed superior cost-effectiveness.

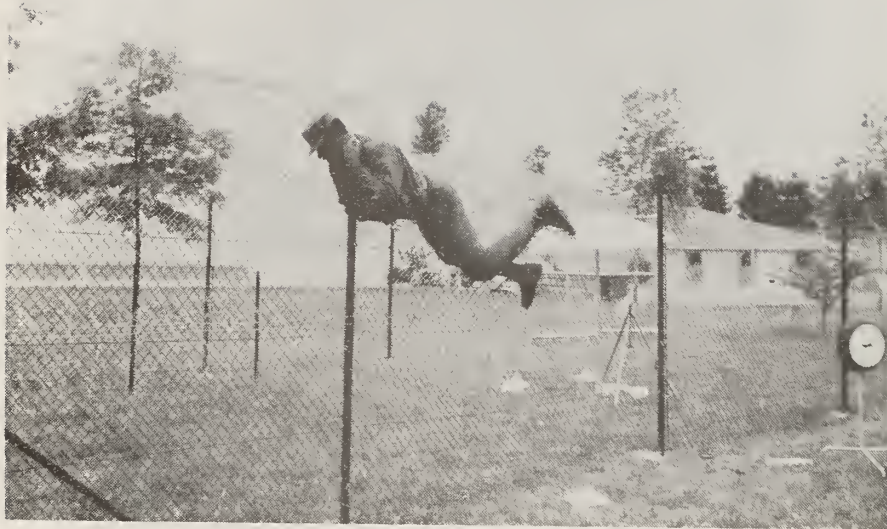
Figure 183. Climbing Fence Bare-handed;  
Test F3

As shown in figure 183, climbing the fence was accomplished bare-handed in 0.07 minute.

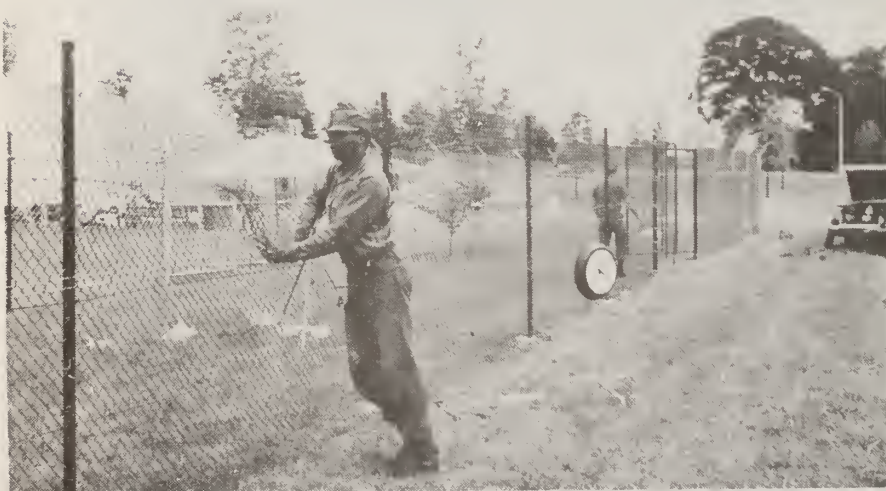
Figure 184. Pulling Down Fabric from  
Top Tension Wire in  
Preparation for Climb-over;  
Test F3

As shown in figure 184, the fabric could be readily pulled down from the top tension wire and this with crawl-over took only 0.10 minute.

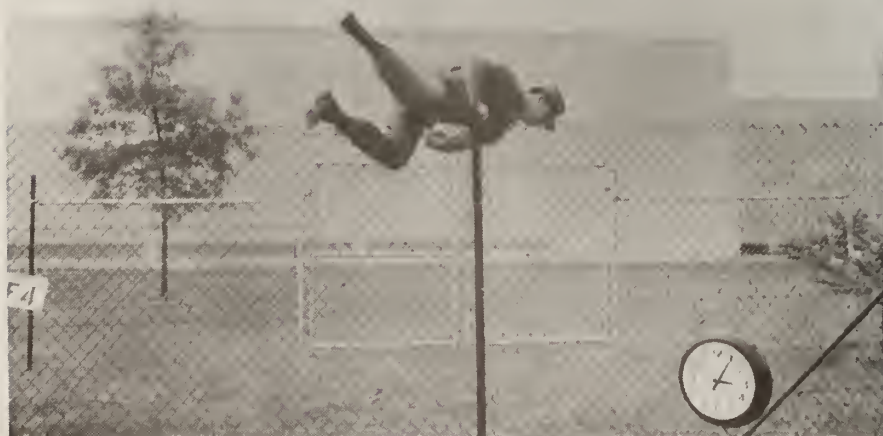
Figure 189. Climb Over Top of Fence;  
Test F4

Climbing over the top of the fence, figure 189, took only 0.07 minute, and, like F3, the fabric could be pulled away from the top tension wire making an opening to crawl over in only 0.12 minute.

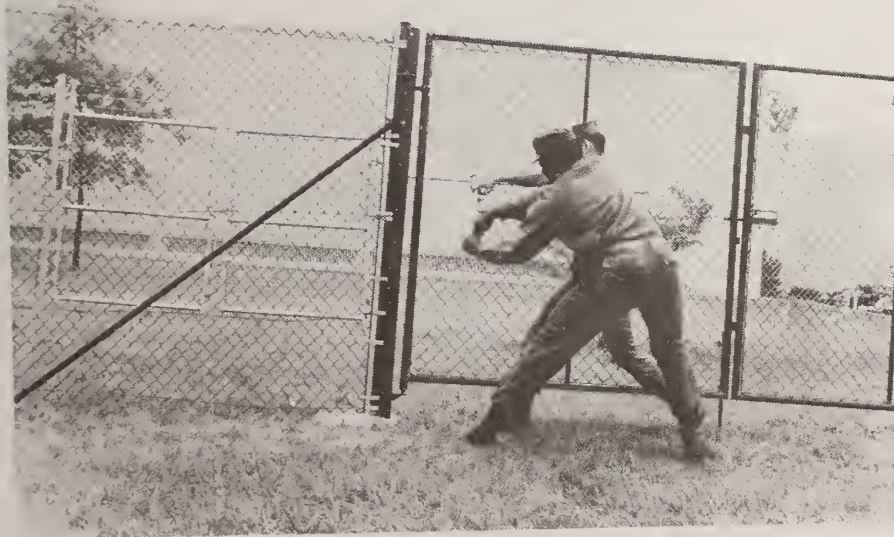
Figure 195. Pulling Metal Fabric  
Away from Frame; Test F4

The metric gate was constructed with the F4 fabric which was attached to the gate frame by rather light tie wires which can be seen in figure 194. These were cut in five places and the fabric was pulled away from the frame as shown in figure 195 producing a half-oval opening that measured 12" X 29" in 0.34 minute.

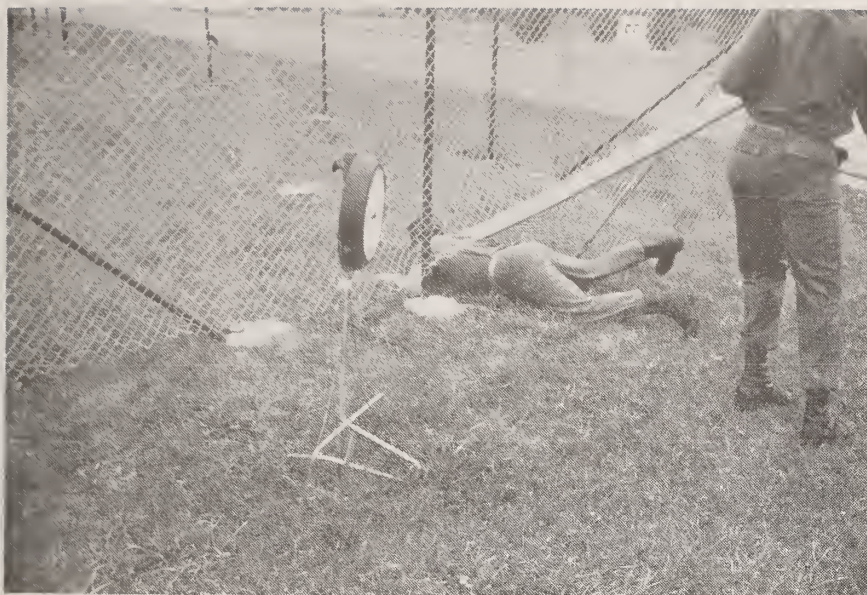
Figure 196. Timber Lift and Crawl Under;  
Test F5

The 2" X 4" timber lift and crawl under, figure 196, took 0.12 minute and a climb over the top took 0.05 minute, figure 197.

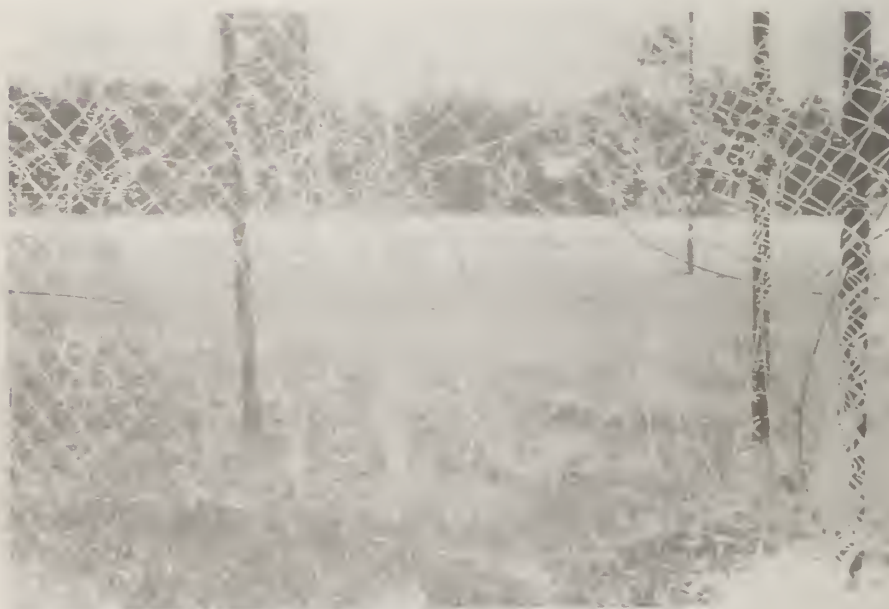
Figure 204. Concertina Wire Spread Apart,  
Hooked to Other Strands Resulting  
in Crawl Through Space; Test F6

Next, a penetration was made through the fence and through the concertina wire immediately behind the fence. First, fabric wires were cut, using linesman's pliers along a diagonal from the ground to a point about 42" high. This provided an opening large enough to manipulate the concertina wire. The three lower tension wires were also cut and the ends pulled aside. A multiple sweep trace of some of the vibrational disturbances produced by the wire cutting is shown in figure 203. Then the strands of concertina wire were spread apart and hooked to other strands so as to provide an open area through the bottom two coils which was large enough for a man to crawl through, as shown in figure 204. The hooks which were used were made from three-inch lengths of No. 9 gauge wire which had short reverse bends at each end. After the concertina wire had been hooked apart, two men crawled through the opening.

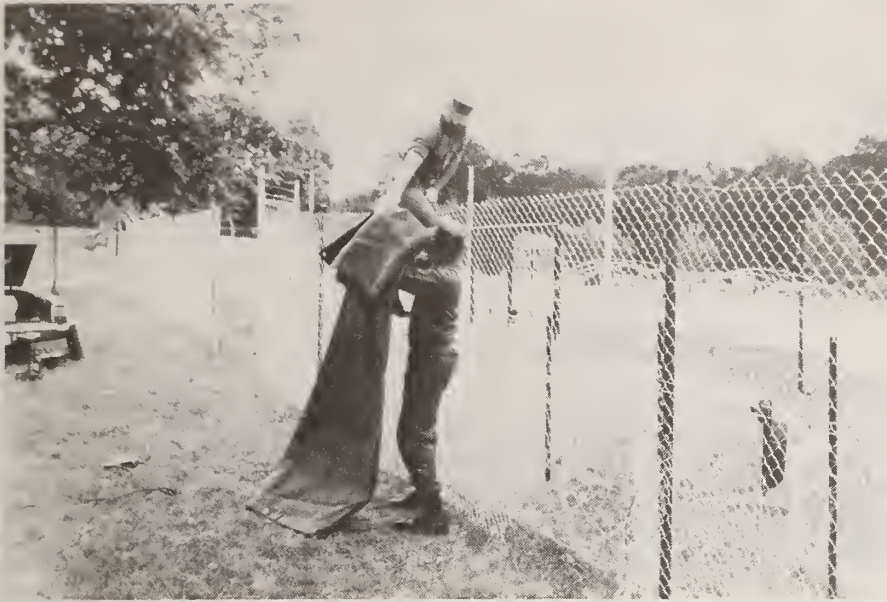
Figure 205. Climb to Throw Heavy  
Tarpaulin over Concertina  
Wire ; Test F6

Figures 205, 206, and 207 demonstrate yet another technique which permits a two-man team to get one man inside the fence and concertina wire in 0.53 minute. One man provides support for the second who climbs up and throws a heavy folded tarpaulin across the top of the concertina wire. He then climbs to the top of the fence and leaps across the concertina. In this instance, the tarpaulin simply provided a safety factor as the leap cleared the concertina wire entirely. Figure 208 shows vibrational disturbances during the climbing with the transducer at a distance of about four feet.

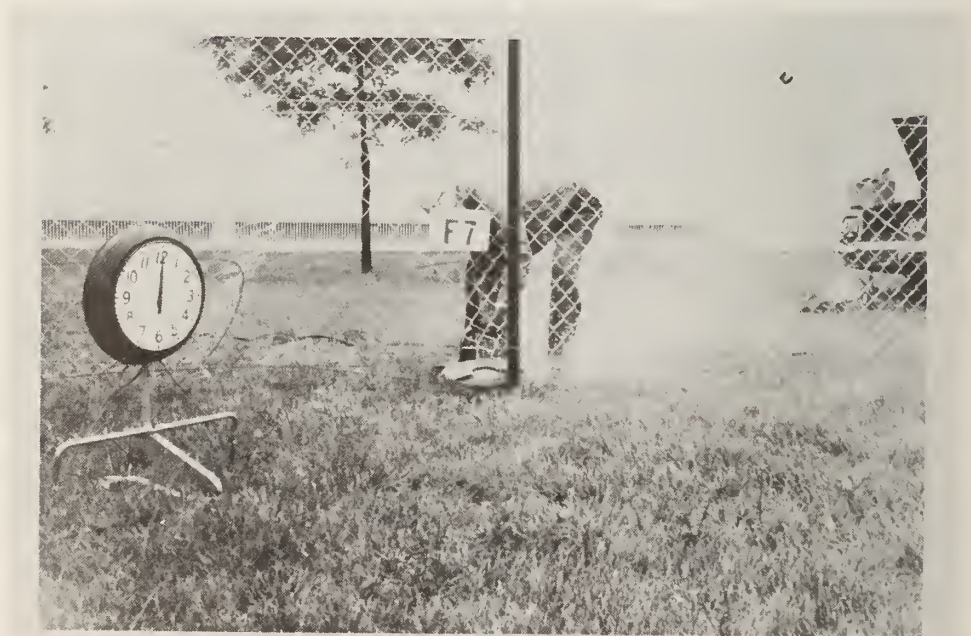
Figure 210. Cutting Metric Intermediate Post  
near Ground with Abrasive Wheel Saw;  
Test F7

The gasoline-powered abrasive wheel saw was used to cut off one of the metric intermediate posts near the ground, as shown in figure 210. This took 0.16 minute and produced vibrational disturbances, as shown in figure 211, with the transducer at a distance of 10' from the post. Figure 212 shows the comparative cross sections of the two types of intermediate fence posts used.
